MSFC MPR-SAT-FE-73-1

## SATURN V LAUNCH VEHICLE FLIGHT EVALUATION REPORT-AS-512 APOLLO 17 MISSION

Saturn V AS-512 (Apollo 17 Mission) was launched at 00:33:00 Eastern Standard Time (EST) on December 7, 1972, from Kennedy Space Center, Complex 39, Pad A. The vehicle lifted off on a launch azimuth of 90 degrees east of north and rolled to a flight azimuth of 91.504 degrees east of north. The launch vehicle successfully placed the manned spacecraft in the planned translunar coast mode. The S-IVB/IG impacted the lunar surface within the planned target area.

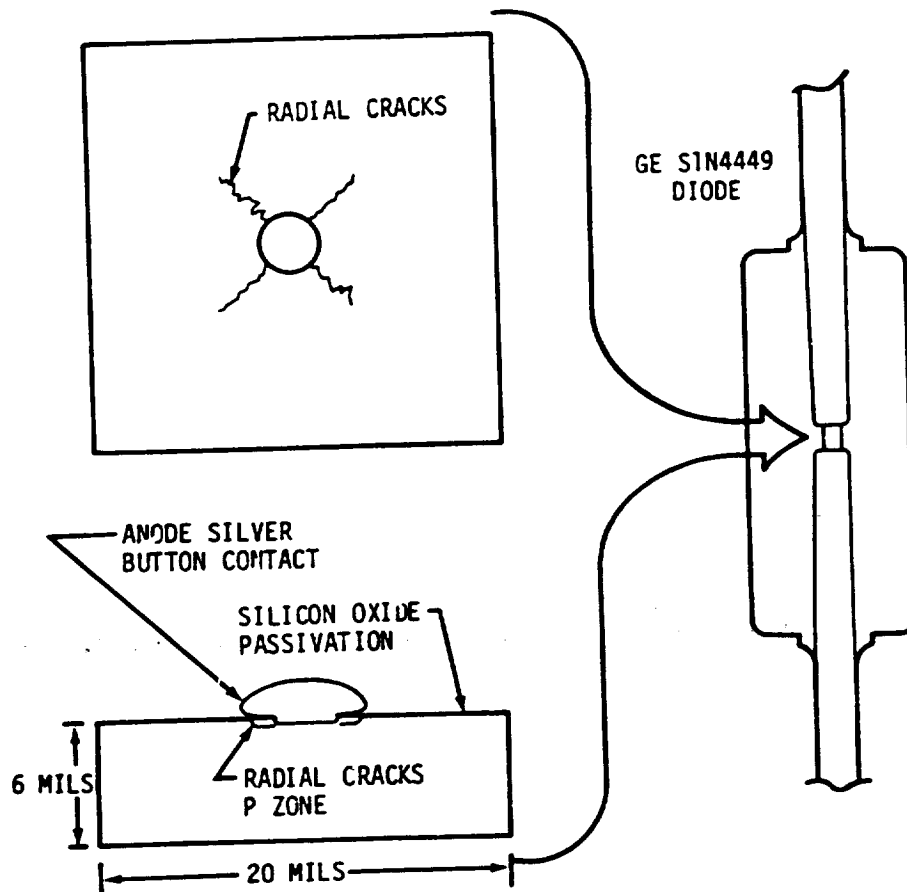
Figure 3-2. Diode Chip Detail

Since deposition of contamination in microscopic cracks (Figure 3-2) was consistently observed in the failed diodes, this is considered to be the most probable failure mode. However, the investigation as to the cause of the cracks and subsequent contamination deposition is still underway and cannot be considered conclusive at this time.

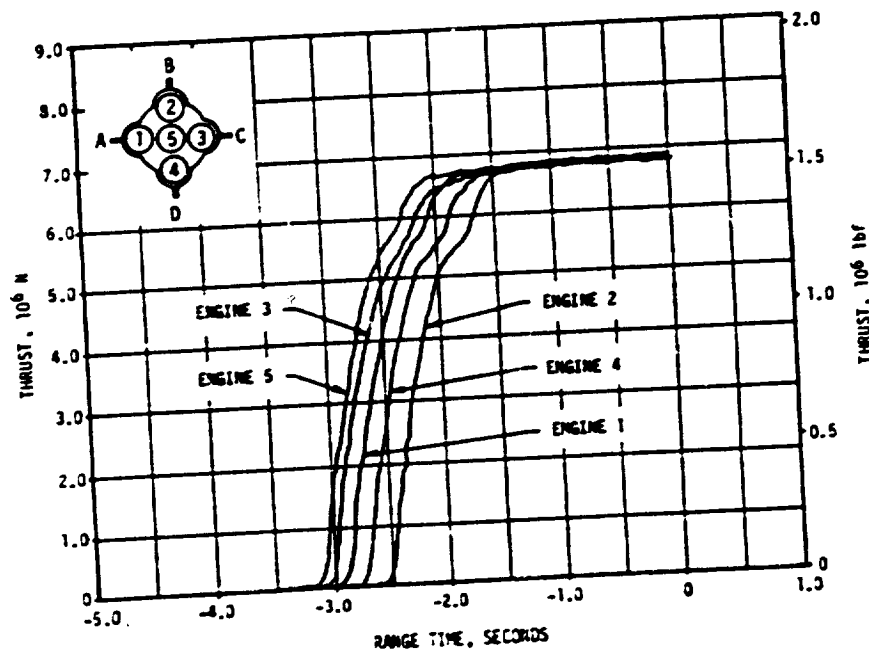
Figure 5-2. S-IC Engines Thrust Buildup

Thrust buildup rates were as expected, as shown in Figure 5-2.

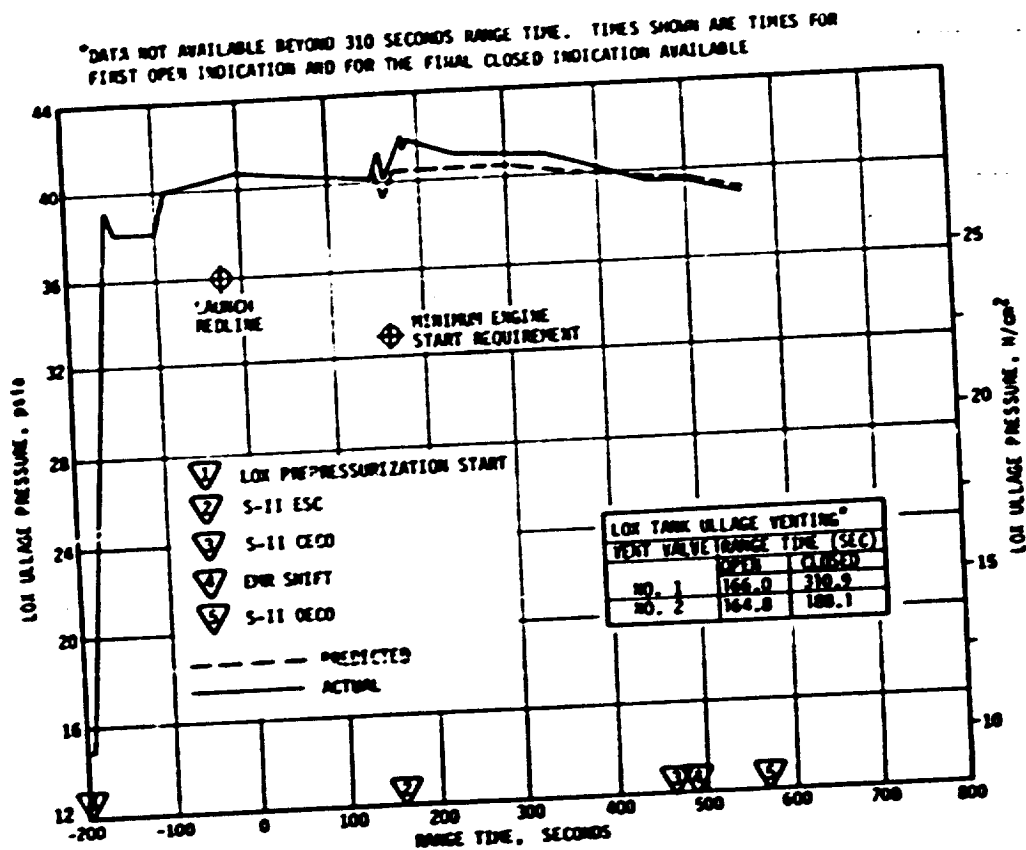
Figure 6-10. S-II LOX Tank Ullage Pressure

LOX tank ullage pressure, actual and predicted, is presented in Figure 6-10 for autosequence, S-IC boost, and S-II burn. After a 107 second cold helium chilldown flow through the LOX tank, the chilldown flow was terminated at -200 seconds. The vent valves were closed at -184 seconds and the LOX tank was pressurized to the pressure switch setting of 38.5 psia in 31.0 seconds. No pressure make-up cycles were required. The LOX tank ullage pressure increased to 40.0 psia because of common bulk-head flexure during LH<sub>2</sub> tank prepressurization. Ullage pressure at -19 seconds (launch commit) was 40.2 psia which is within the redline limits of 36 to 43 psia. The LOX vent valves performed satisfactorily during all prelaunch operations.

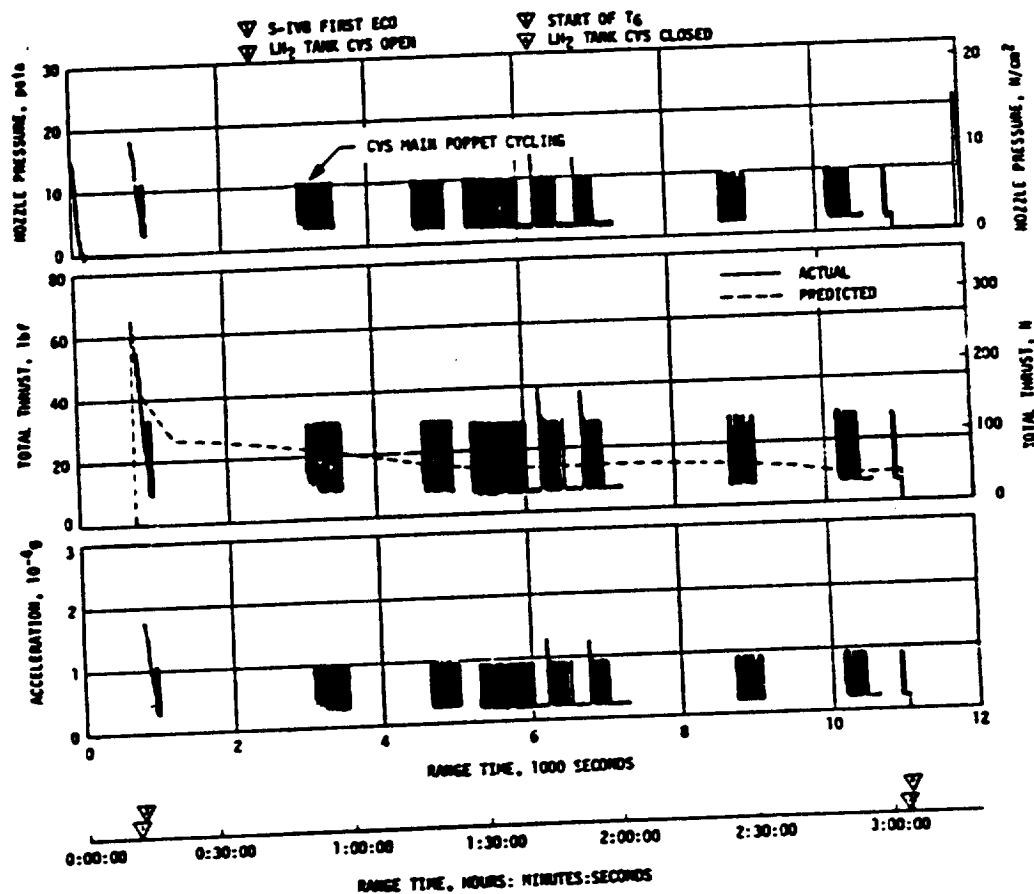
Figure 7-5. S-IVB CVS Performance - Coast Phase

The continuous vent regulator was activated at 761.8 seconds and was terminated at 11,020.8 seconds (03:03:40.8). The CVS performance is shown in Figure 7-5.

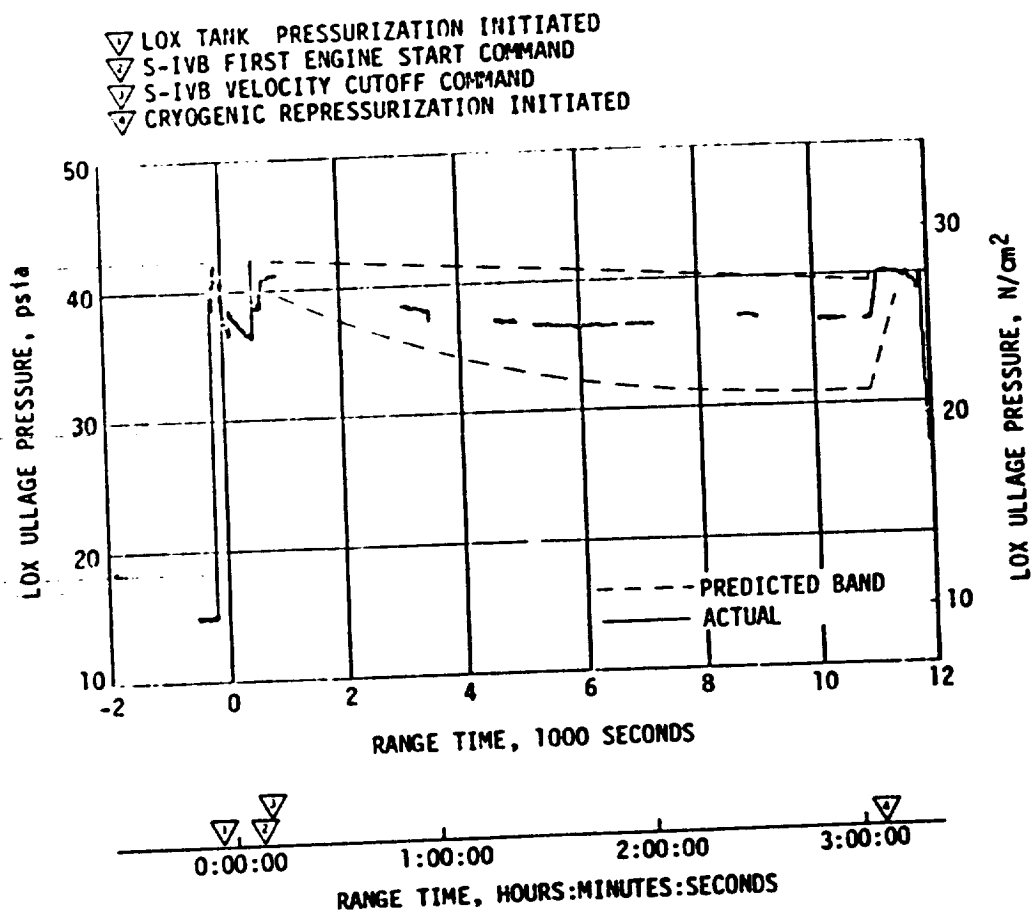
Figure 7-13. S-IVB LOX Tank Ullage Pressure - First Burn, Earth Parking Orbit, and Second Burn

LOX tank prepressurization was initiated at -167 seconds and increased the LOX tank ullage pressure from ambient to 40.1 psia in 14.9 seconds, as shown in Figure 7-13. Three makeup cycles were required to maintain the LOX tank ullage pressure before the ullage temperature stabilized.

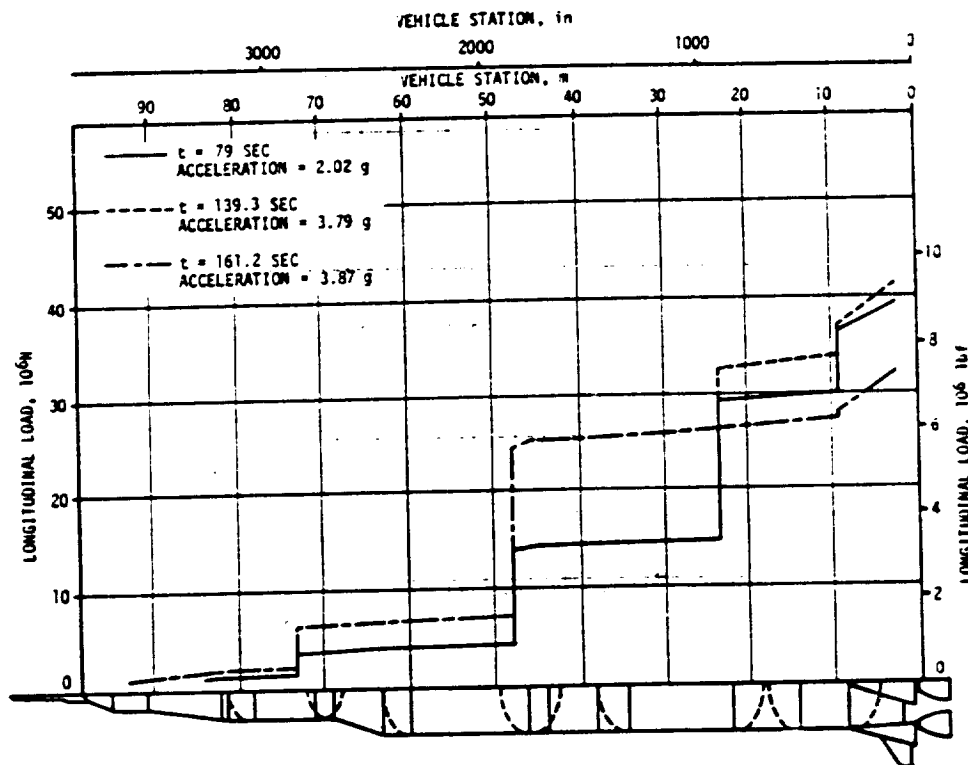
Figure 8-2. Longitudinal Load Distribution at Time of Maximum Bending Moment, CECO and OECO

Combined compression and tension loads were computed for the maximum bending moment, CECO and OECO conditions, using the loads shown in Figures 8-2 and 8-3 and measured ullage pressures. Those loads which produced minimum safety margins are plotted versus vehicle station along with the associated capabilities in Figure 8-4. The minimum ratio of capability to load is at Station 1541 for the OECO condition.

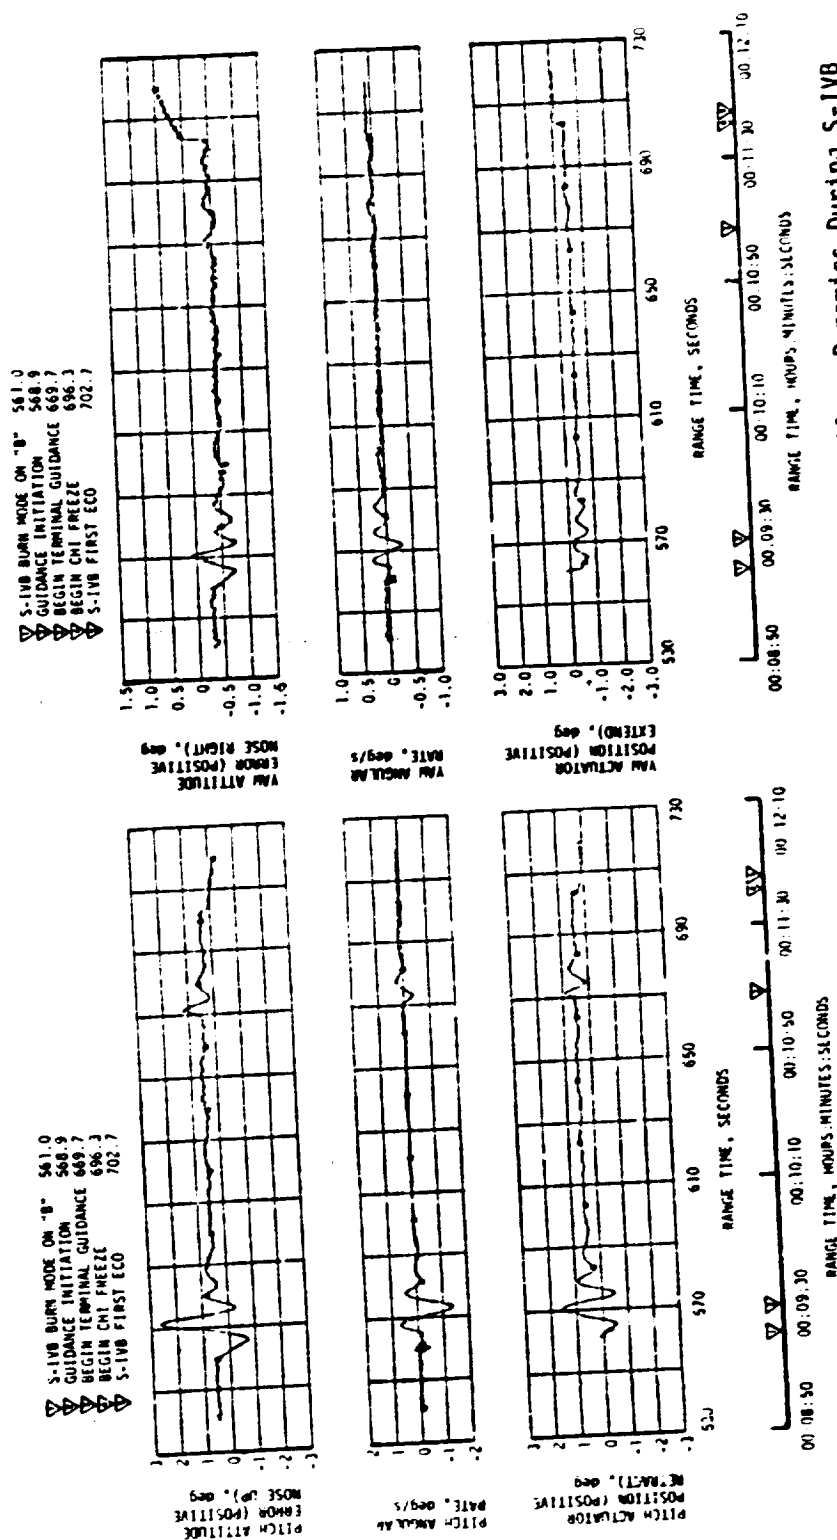
Figure 10-6. Pitch Plane Dynamics During S-IVB First Burn

S-IVB first burn pitch attitude error, angular rate, and actuator position are presented in Figure 10-6. First burn yaw plane dynamics are presented in Figure 10-7. The maximum attitude errors and rates occurred at IGM initiation. A summary of the first burn maximum values of critical flight control parameters is presented in Table 10-4.

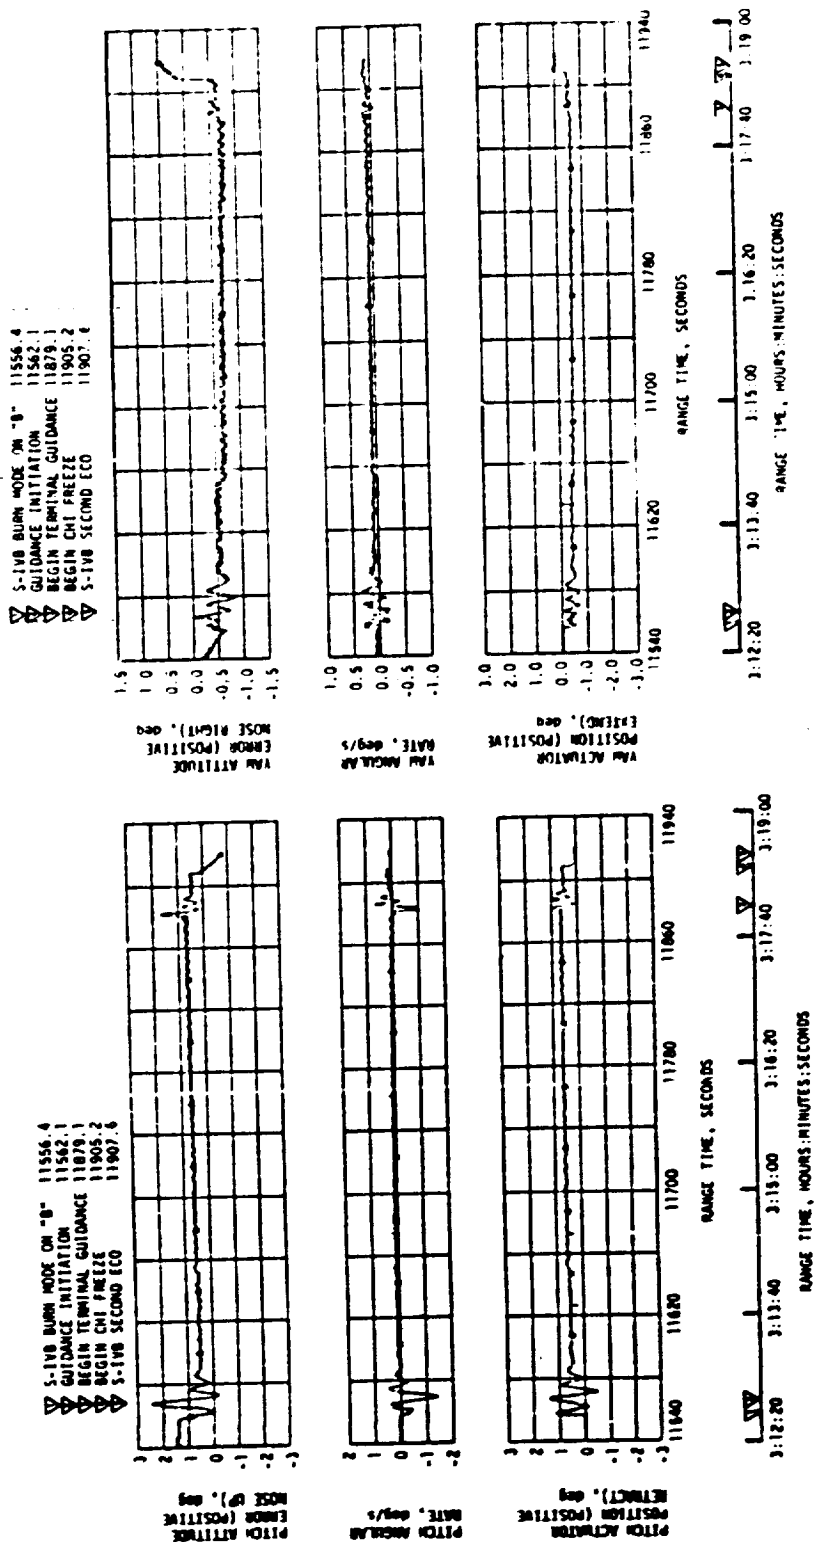
Figure 10-9. Pitch Plane Dynamics During S-IVB Second Burn

S-IVB second burn pitch attitude error, angular rate, and actuator position are presented in Figure 10-9. Second burn yaw plane dynamics are presented in Figure 10-10. The maximum attitude errors and rates occurred following guidance initiation. Transients were also observed as a result of the pitch and yaw attitude commands at the termination of the Artificial Tau guidance mode (27 seconds before ECO).

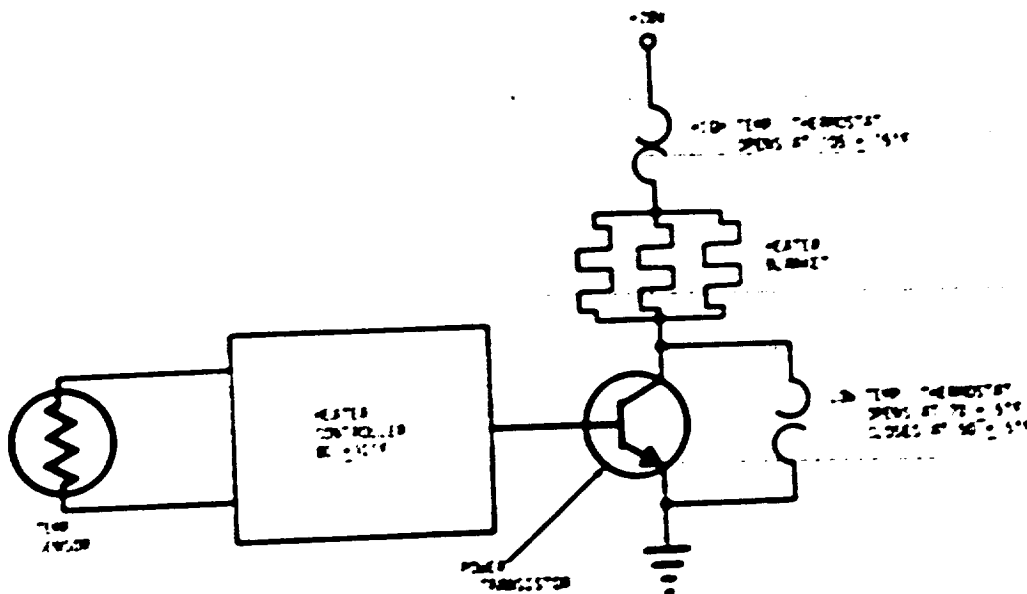
Figure 11-6. S-1VB Aft Battery No. 1 Unit No. 1 Heater Control Circuit

The temperature of the S-IVB Aft Battery No. 1, Unit No. 1, increased significantly above the nominal cutoff limit (90°F) of the primary heater control system at approximately 9.0 hours (see Figure 11-5). The temperature of Unit No. 1 continued to increase until the high temperature backup thermostat deenergized the heater at approximately 120°F (see Figure 11-6). The temperature then decayed to approximately 87°F at which point the heater was energized. Since the high temperature thermostat has a small temperature deadband and the heater did not cycle around the high temperature thermostat control point, temperature control of Unit No. 1
